**KOOTENAI DEVELOPMENT IMPOUNDMENT DAM**

**AUGUST 2011 ROUTINE OWNERS INSPECTION**

Prepared by: Kurt Hafferman, P.E.

Inspection Date: August 25<sup>th</sup>, 2011  
Report Date: December 29, 2011

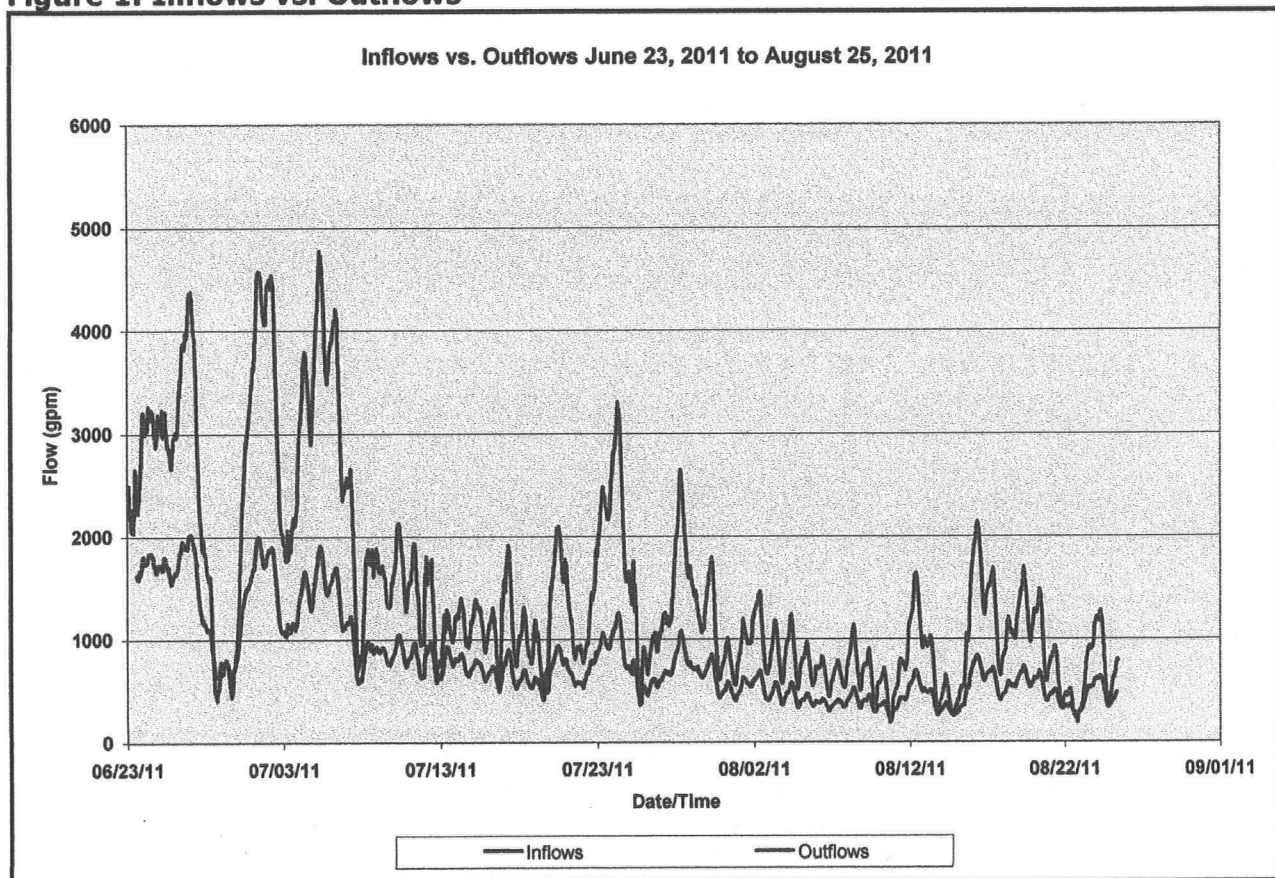
**Figure 1: Inflows vs. Outflows**

In the graph above, we can see that outflows have been consistently higher than inflows but we also see that it appears flows are beginning to stabilize. Inflows include Upper Rainy Creek and calculated and measured Fleetwood Creek inflows and the measured outflows include toe drain and spillway flow below the toe of the dam. It is interesting to note that the flow patterns above and below the impoundment have nearly matching changes in pressure head as measured in a Solinst® transducer.

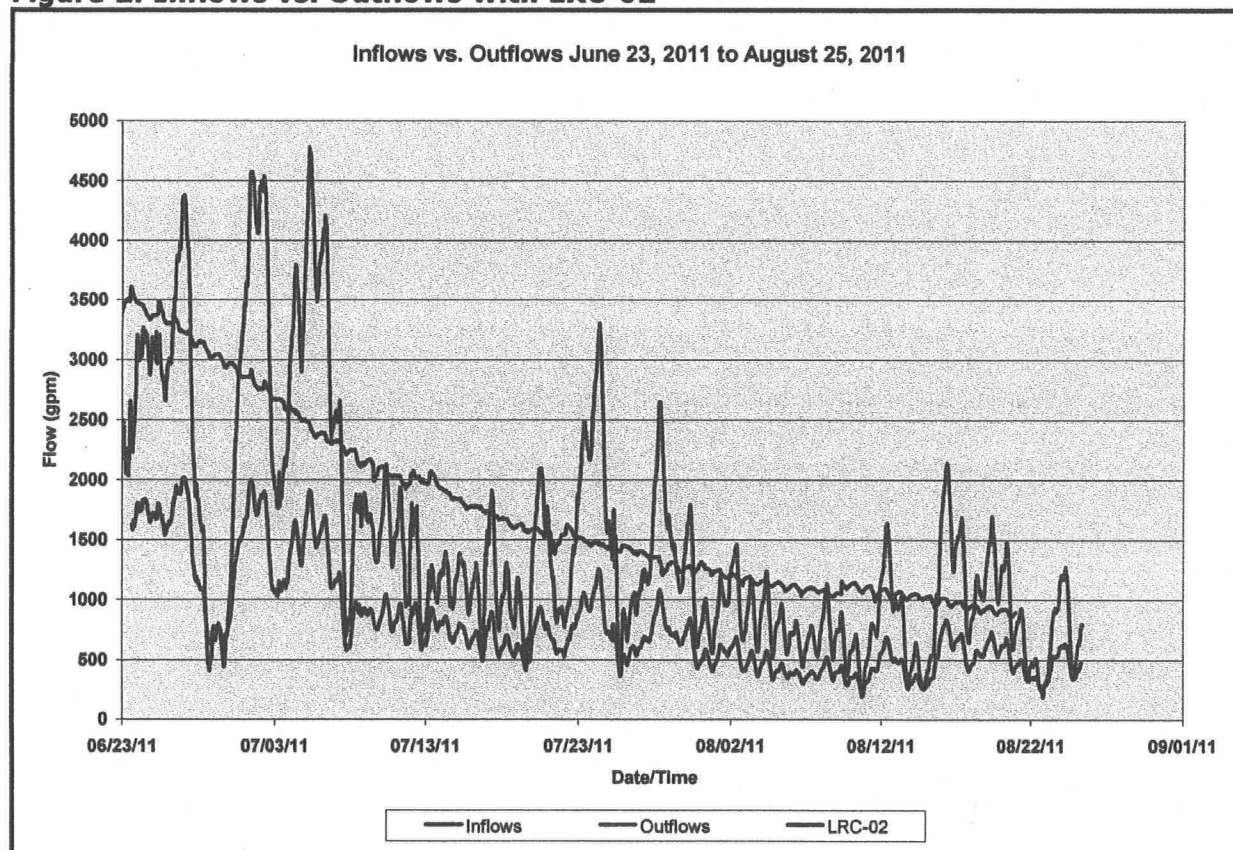
**Figure 2: Inflows vs. Outflows with LRC-02**

The graph above is the same as Figure 1 except it includes the flow data obtained from MWH Global for the LRC-02 flume. As can be seen the flow changes in the MWH Global LRC-02 flume are much more subdued to those measured at BHI URC-02 and LRC-01. It is assumed that the attenuation of flows from LRC01 is provided at the mill pond. As can be seen, the LRC02 flow fluctuations are gradual declines with very little day-to-day fluctuations when compared to reservoir inflows and the toe of the dam. The data shows that the mill pond and the outflow are acting as expected and that the reservoir impoundment above the KDID and the outflows below are not.

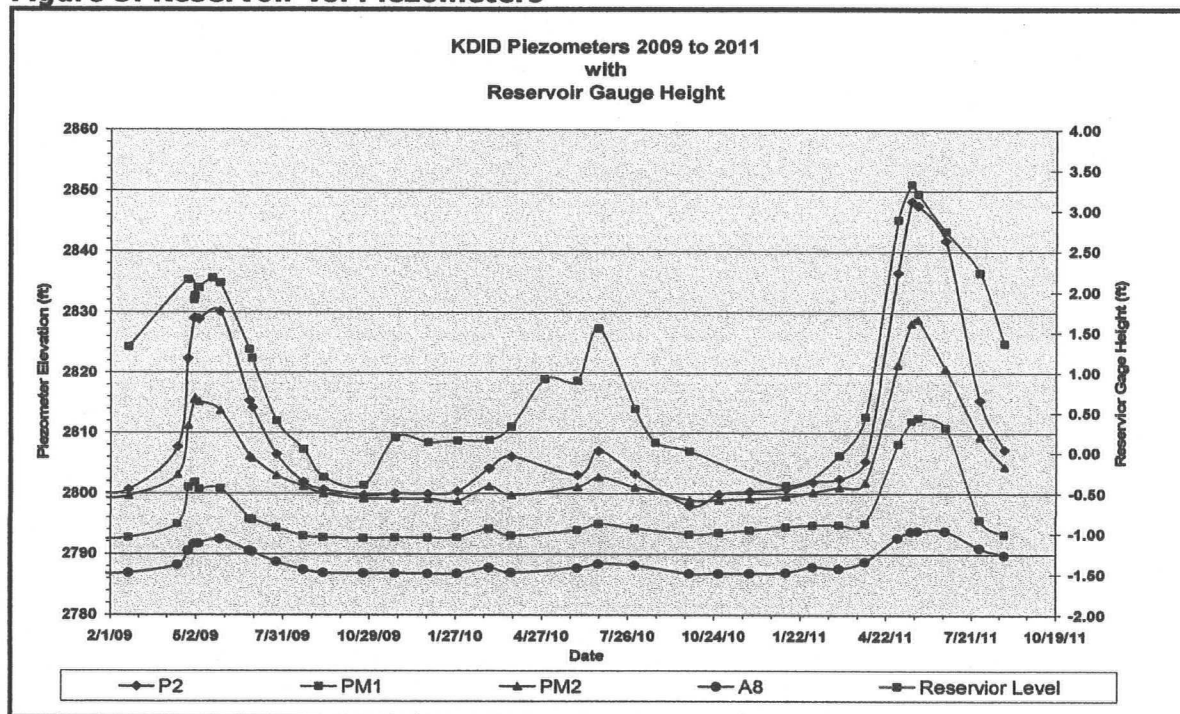
**Figure 3: Reservoir vs. Piezometers**

The reservoir is still approximately 1 foot higher than has been normal for this time of year but is nearing normal levels. Reservoir levels and piezometers levels have been found to be correlated over the season in that they rise and fall in unison. It has been noted, and as discussed in the piezometer section below, the day-to-day changes in reservoir level are not always reflected in the piezometers; just the seasonal trends. It is also shown that the reservoir rise and piezometer response was quicker and reached levels much higher than average and higher than any other year monitored by BHI which is a reflection of the amount of runoff this spring compared to recent years. Figure 3 below shows the updated reservoir level versus the piezometer levels over the last three years.

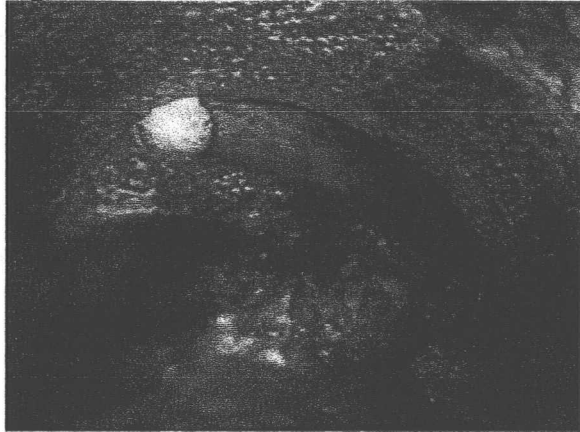
**Figure 4: Drain 3 Terminal End 2010 vs. 2011**

Also noted were changes at the terminal end. The video revealed what appears to be new rock and concrete or new rocks that do not have the dark oxidized covering, at the terminal end of the pipe. The terminal end of drain 3 is shown in Figure 4 below in 2010 and 2011. On the left side in Figure 4 is the terminal end of drain 3 in 2010. Note the rounded concrete pipe below the white rock on the left side. Close inspection shows the concrete is well defined and there is a protrusion of the old pipe and then a small void then the gravel in the drain. In the 2011 terminal end, the lip of the concrete is not defined under the white rock and new rocks appear that are clean and not oxidized.

The video confirmed that material transport has occurred and is coming from the terminal end of the pipe. Also noted is water entering perpendicular and slightly above the pipe on the right side of the video at the terminal end of drain 3; which was not noted in 2010. It was also noted that a triangular piece of concrete was also missing on the right side of the pipe. Figure 5 below shows the cross drain at the terminal end of drain 3.

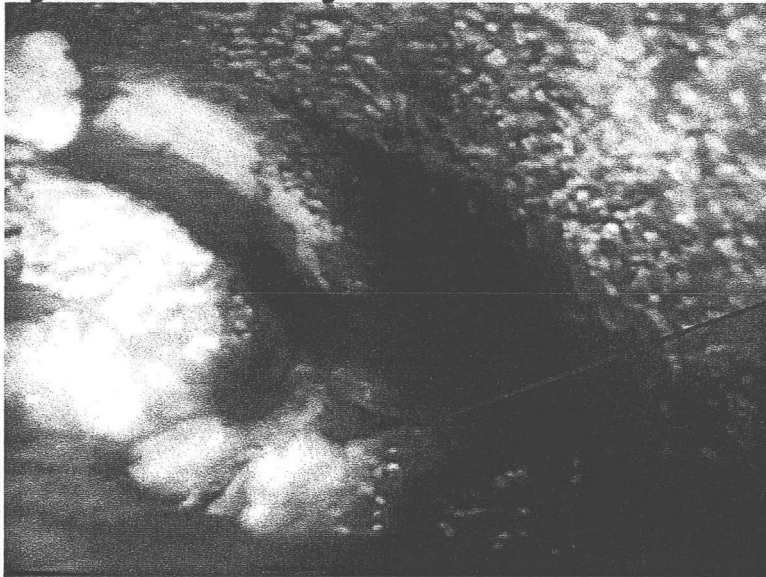
**Figure 5: Water Entering Drain 3**

Perpendicular  
Flow Entering the  
Pipe

There terminal end of drain 3 is located 128.5 feet in from the toe of the dam and closely matches the location of the cross drain shown in the Phase 1 inspection report by Morrison and Maierle, Inc. It may be possible that the flow entering drain 3 perpendicular may be an indication that drain 3 is located at the Phase 1 cross drain location. It is also speculated that the cross drain could be the source of gravel during the high flow events. As discussed, last month a noticeable increase of material at the outlet of drain 3 was discovered as compared to pre-spring runoff; which prompted the video inspection. This month the material has washed out of the drain and there is no apparent gravel transport and flows have returned to normal levels and are shown in figure 6 below.

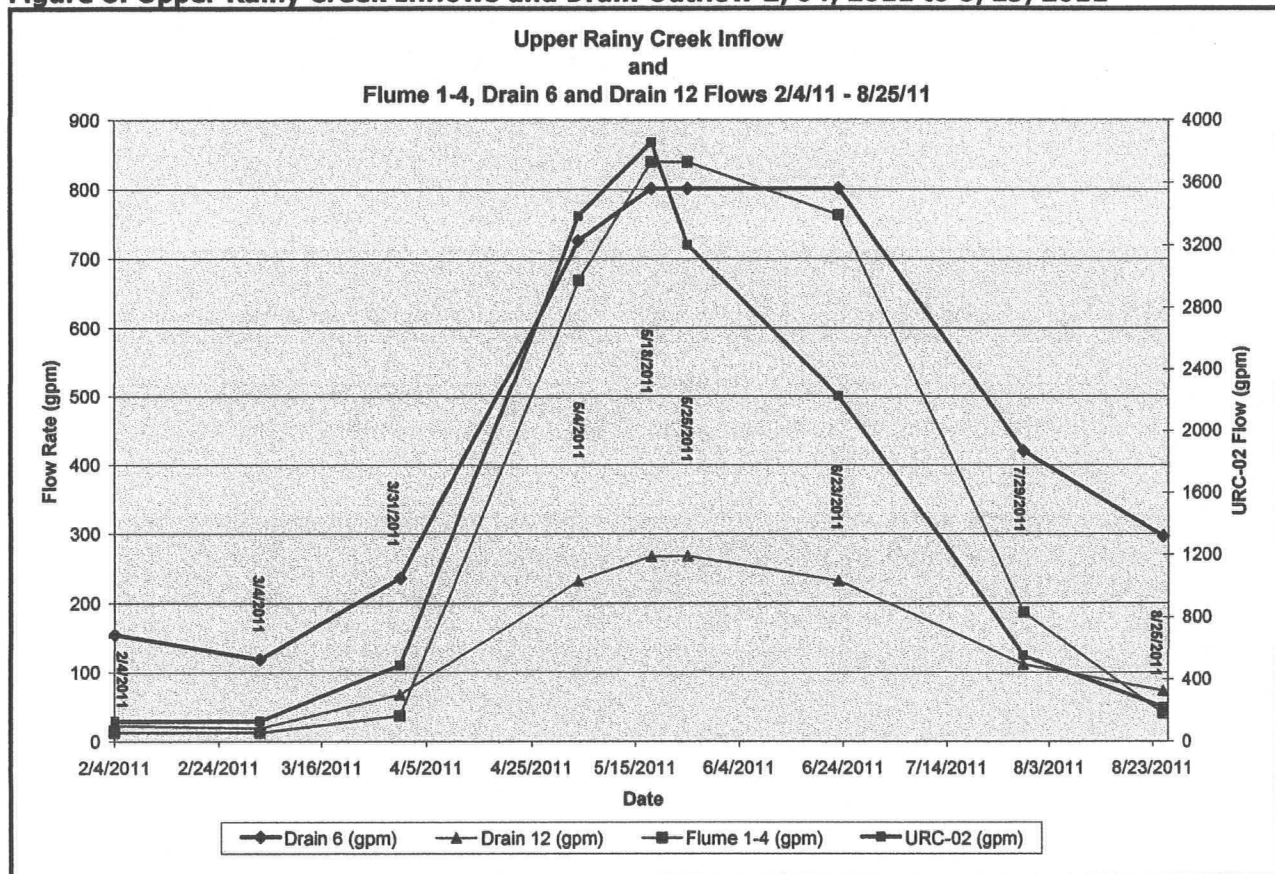
**Figure 8: Upper Rainey Creek Inflows and Drain Outflow 2/04/2011 to 8/25/2011**

As can be seen, and as discussed in the July report and in section 3.3 surface water flow section above, there is a surprising correlation between peak inflow timing and peak drain flow timing.

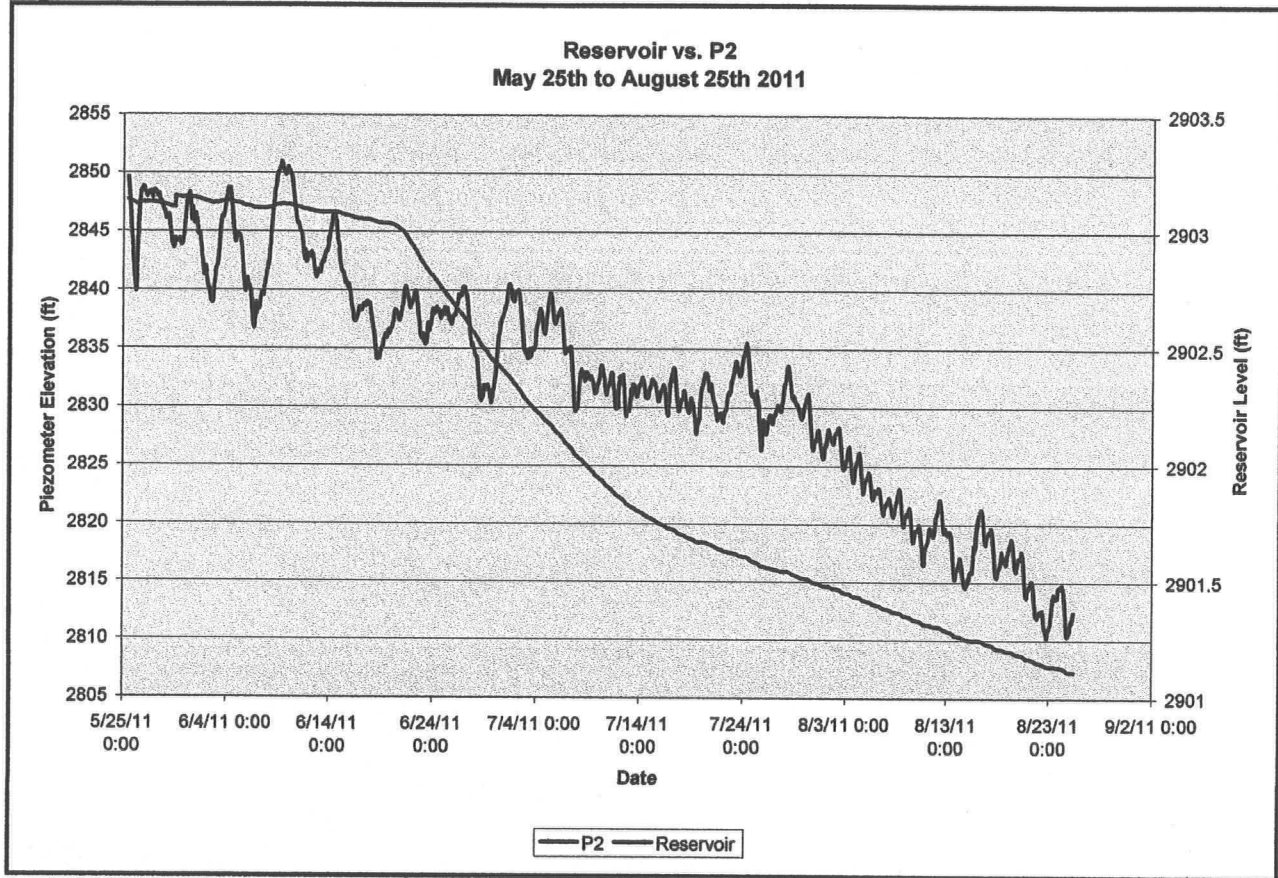
**Figure 9: Reservoir vs. P2**

The graph above shows the continued decline of piezometer P2 and the reservoir. P2 showed no abnormal spikes or changes in August and as shown above is nearing typical levels. The piezometer water level has dropped over 40 feet since peak levels were measured on May 18<sup>th</sup> this spring.

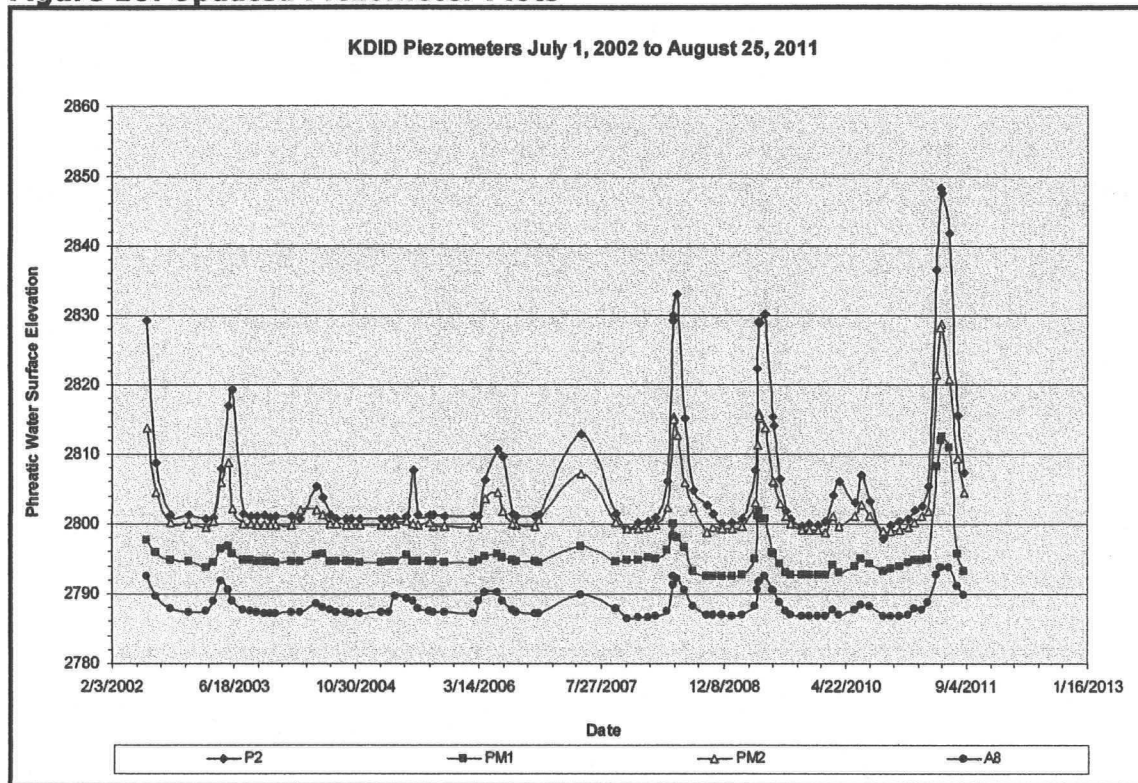
**Figure 10: Updated Piezometer Plots**

In the graph above, we see that with the exception of the record high piezometer levels, the level changes within the dam follow the pattern seen in most years except they are at higher levels than previously recorded. Figure 11 below shows the same piezometers, but over a shorter period of time with more consistent data.

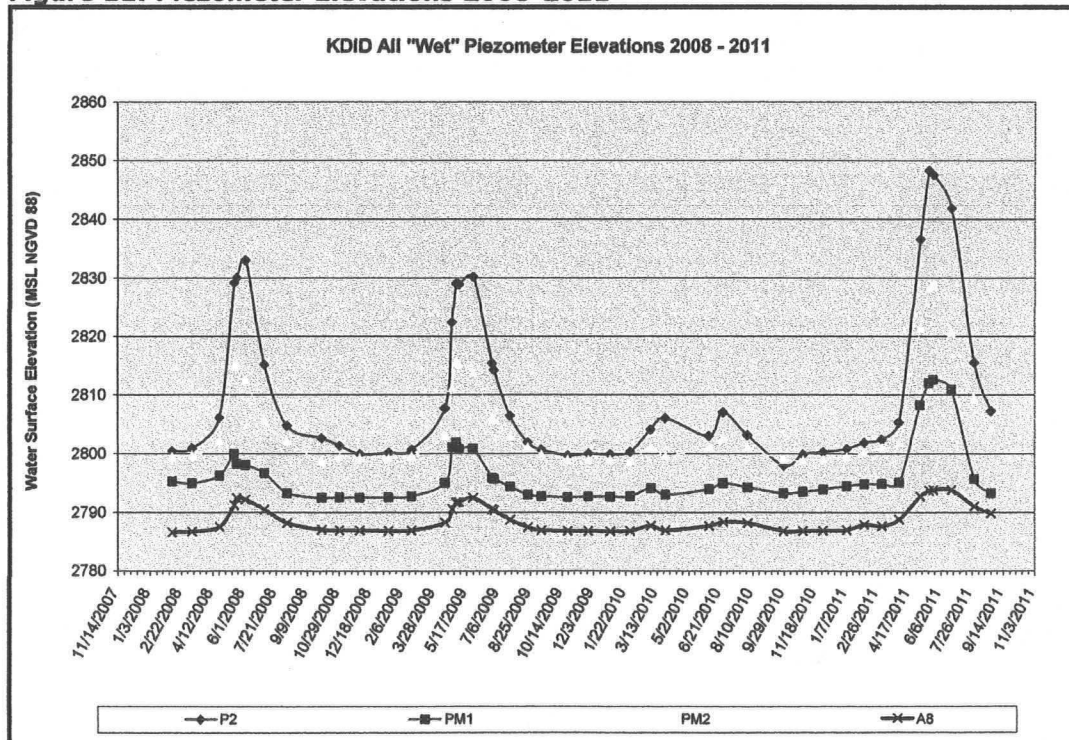
**Figure 11: Piezometer Elevations 2008-2011**

The graph above represents data collected since BHI began onsite inspections. We see that with the exception of 2010, which was a low precipitation year, that there is an annual cycle that the phreatic water surface in the dam follows. This spring the peak levels were higher than any other data but the cycle has remained the same. The only notable difference other than the peak levels is that piezometer A8 appears to be receding slower than normal and shows a prolonged groundwater influence that has not been previously noticed. Figure 13 below shows piezometer A8.

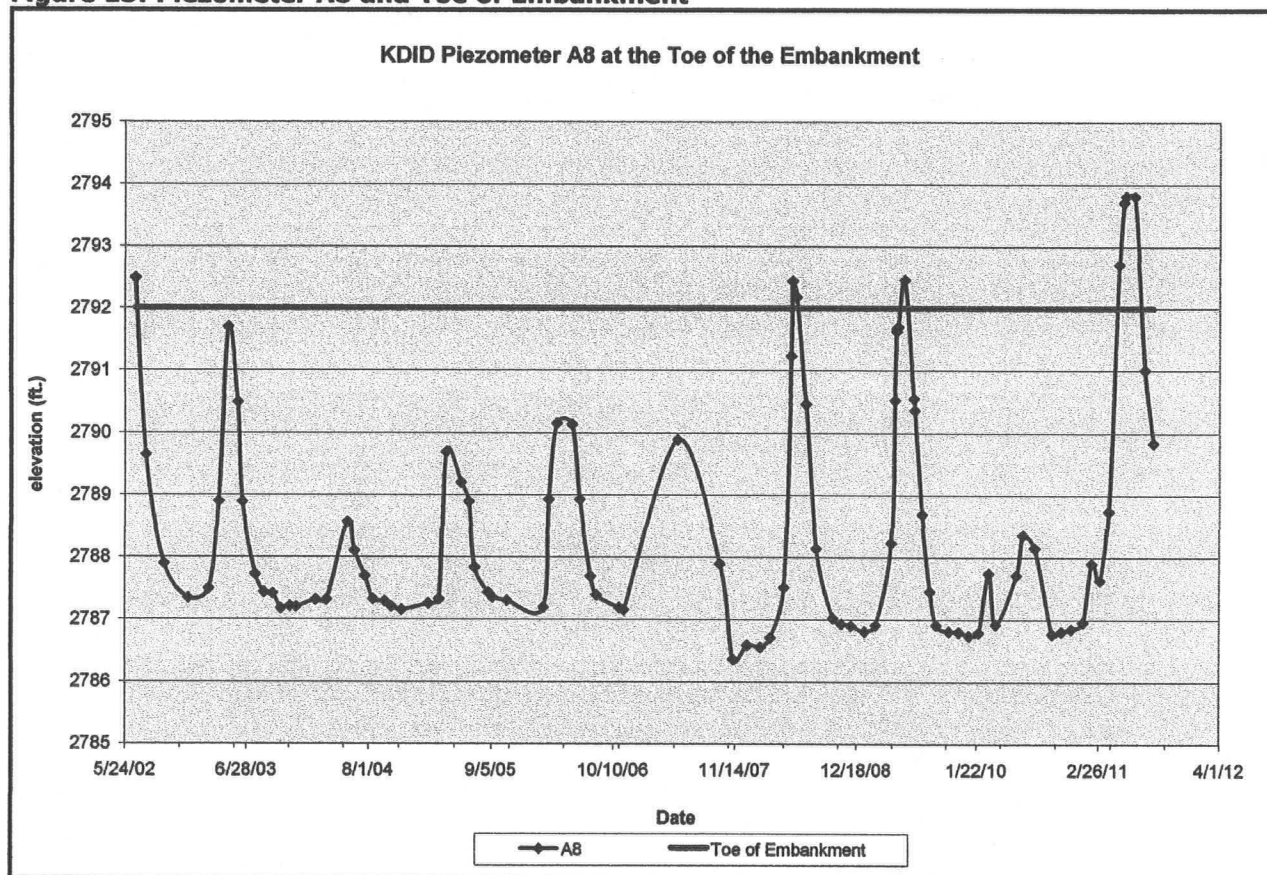
**Figure 13: Piezometer A8 and Toe of Embankment**

Piezometer readings have continued their decline and are beginning to stabilize at near normal levels with the exception of piezometer A8 which is still measuring well above past records. The higher levels in piezometer A8 indicate that groundwater levels in the foundation are still high and confirm that there is an upward groundwater gradient that is higher than the elevation of the drains. The level is expected to fall in the next month as average groundwater flows dropped nearly in half over the past month and indicates groundwater flow influence is receding.

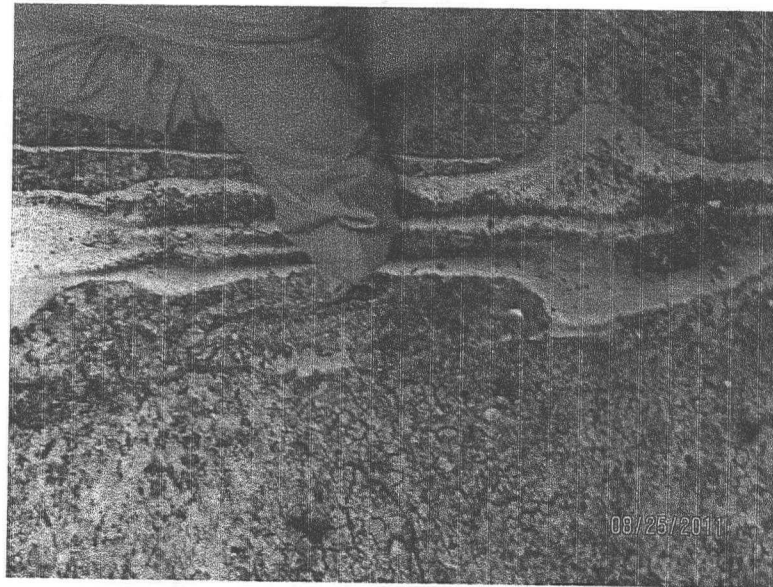
During the inspection one repaired joint was noted as not adhering to the concrete but was less than 2 inches in length and was on the downstream side of the joint. Chapman was told that this joint will require repairs next spring before water flows over the spillway. If the repair can not be completed immediately it will not adversely affect performance or condition of the spillway.

**Joint Repair Separation**

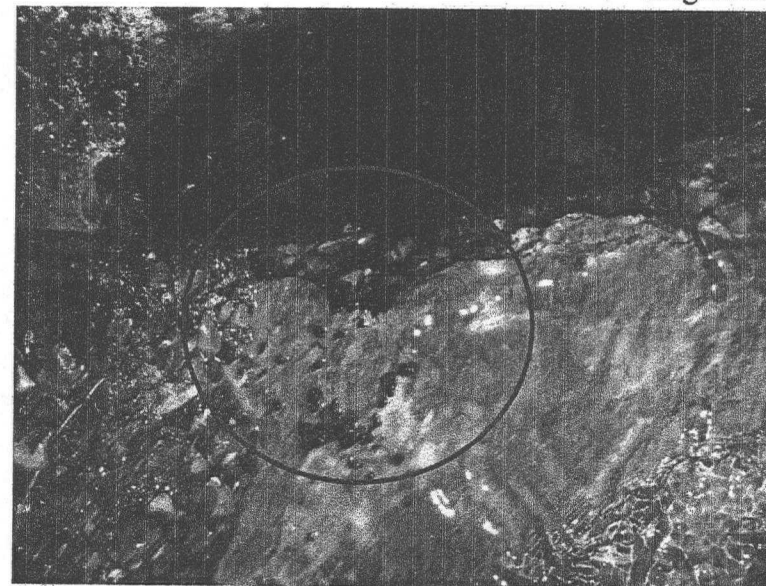
**Sediment Transported out of Drain 2**
